**Solomon Dellinger Homestead
Lincoln County, North Carolina**

Preliminary Site Report

Carolina Preservation Associate LLC

Richard Owens (Feb. 2008)

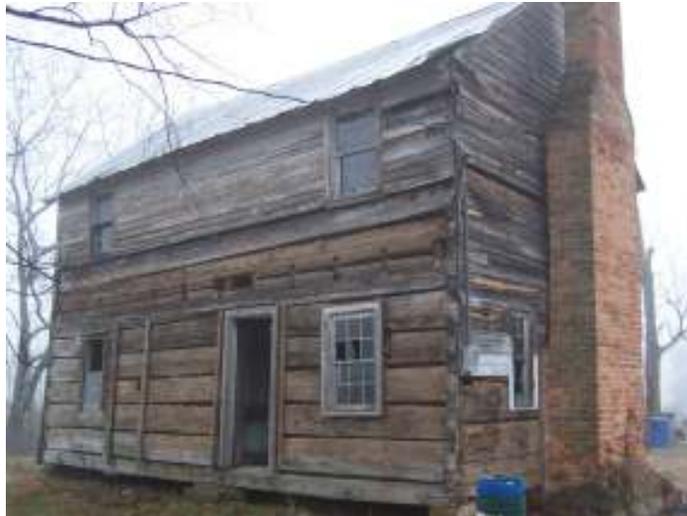
West Elevation

Bottom sill and other 12 log members of the west wall elevation are in good condition. Corner half dovetails are in fair to good condition along the NW and SW elevations. Minor water or insect damage to the window openings and door frame. Missing upper

sash to NW window on first floor. Window sash and frame in fair to good shape (Both floors).

The support stone is stable along this elevation of the log structure.

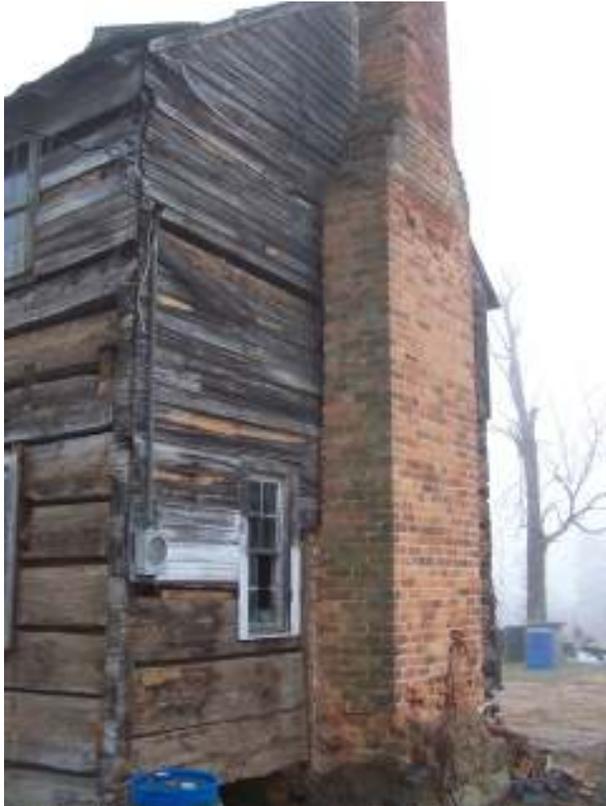
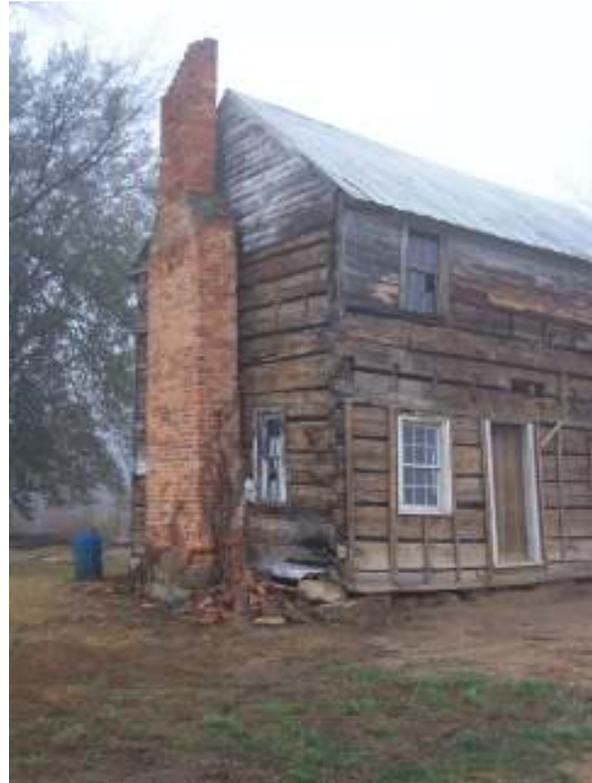
South Elevation

Misc. damaged to log members on the right and left side of chimney structure. There is water damage along the southeast corner, and the bottom sill is fair condition. Only 8 out of 13 log members can be repaired and salvaged to save original south wall elevation (log ends at SE corner have severe water damage – See photo). Both first floor windows units and frame are in fair condition (minor insect damage). There are no windows on the upper second floor. Chimney structure stack and base support are in failure. The brick chimney will need to be dismantled and rebuilt. Gable end wall timber and framing are in good condition. Stone foundation is in good shape. Old termite damage was noted on the bottom sill around chimney.

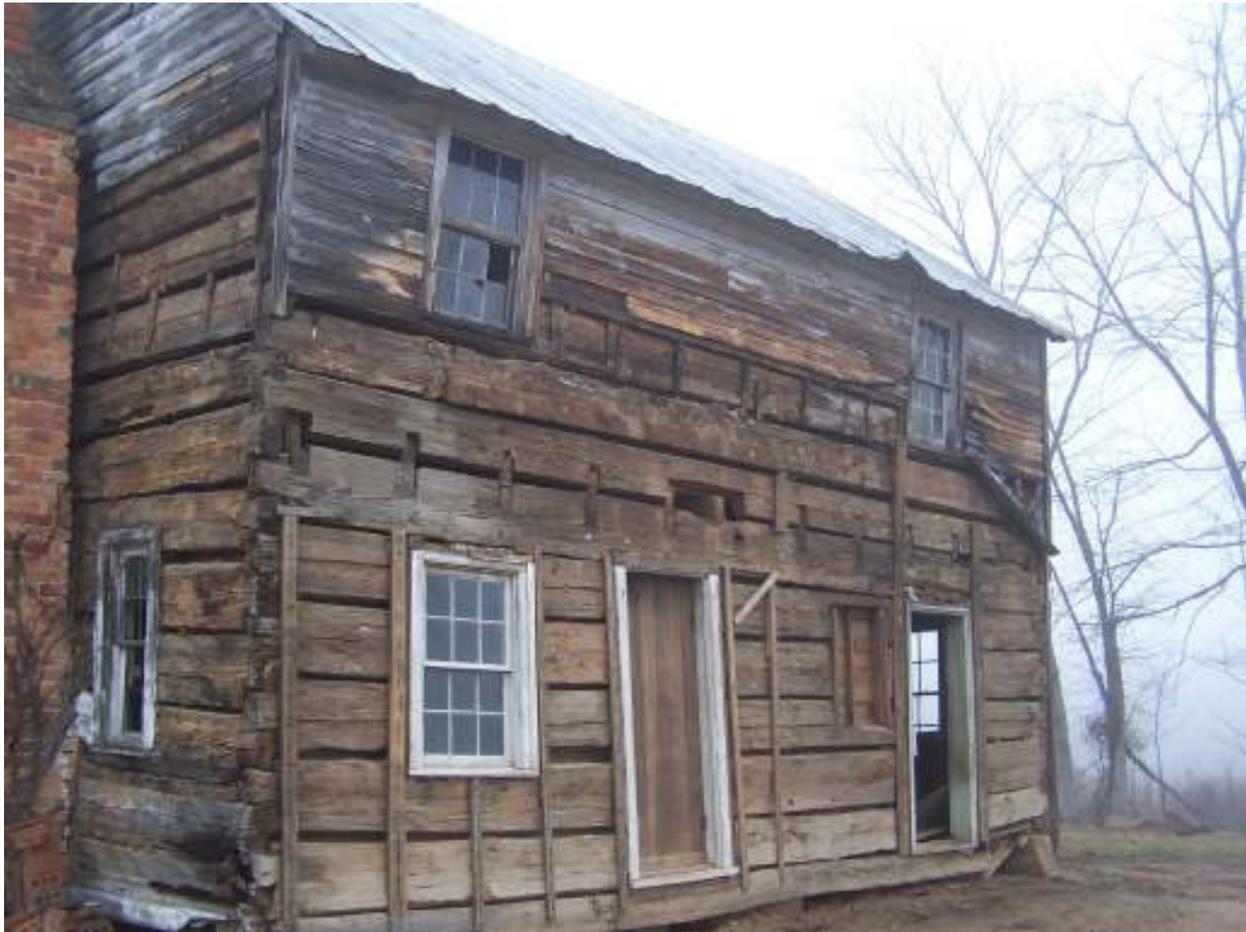
East Elevation

Bottom sill of the east log wall system has failed at the NE corner. The whole wall is deflecting from the bottom member up to the second floor joist connections. Some insect and water damage can be detected along the second to first floor logs along the NE elevation. Except for the bottom wall sill, the remaining log wall members can be repaired and salvaged. Misc. repairs to the SE and NE dovetail corners (fair to good condition from the 5 log member up). Both doors and framework are in good condition. The windows and openings on the first and second floor are in good condition. Both second floor window sashes need to be repaired and refurbished.

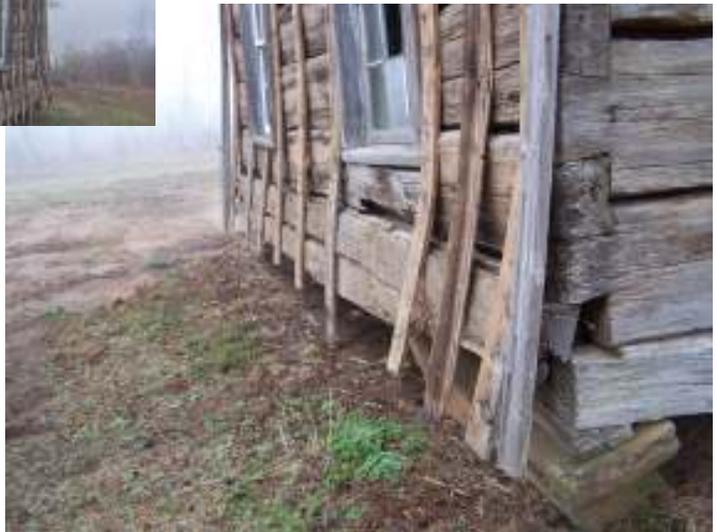
North elevation (Foundation view)

The bottom two log members of this wall are in poor condition. Both lower logs show water damage and are rolling out away from the building (See photo). Upon repairing this section of the wall, both side elevations will need to be stabilized to remove and correct this damaged section of the building. First and second floor window and frame openings are in fair to good shape. Log member No. 4 and higher from the foundation are in fair to good condition. Most of the log members can be repaired and salvaged. Gable end wood timber is in good shape.
